**20 Lower Bore Street, Bodmin, Cornwall**  
**Archaeological Survey and Historical Analysis**

A Report for  
Cornwall Buildings Preservation Trust  
and North Cornwall District Council

March 2001

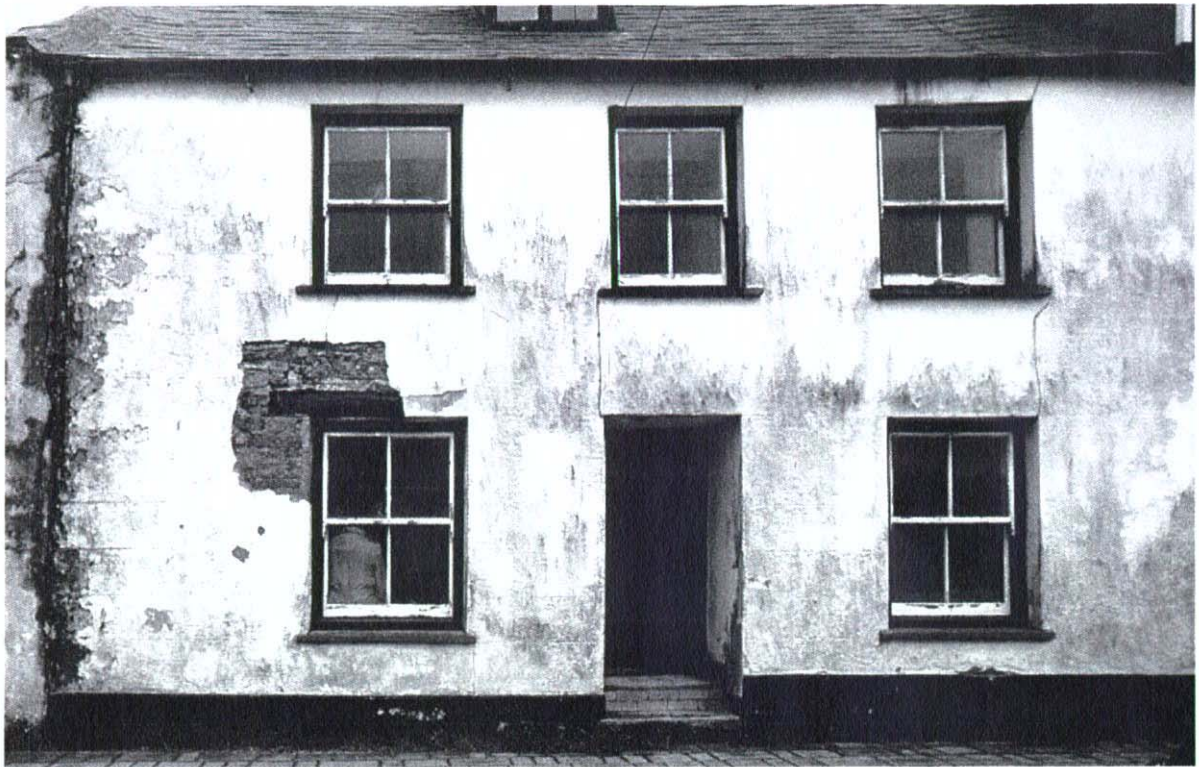
Plate 1 Front elevation (pre works). 20<sup>th</sup> century cement-based render resembling stucco with incised lines to resemble ashlar; re-used oak lintel revealed as part of enabling works.

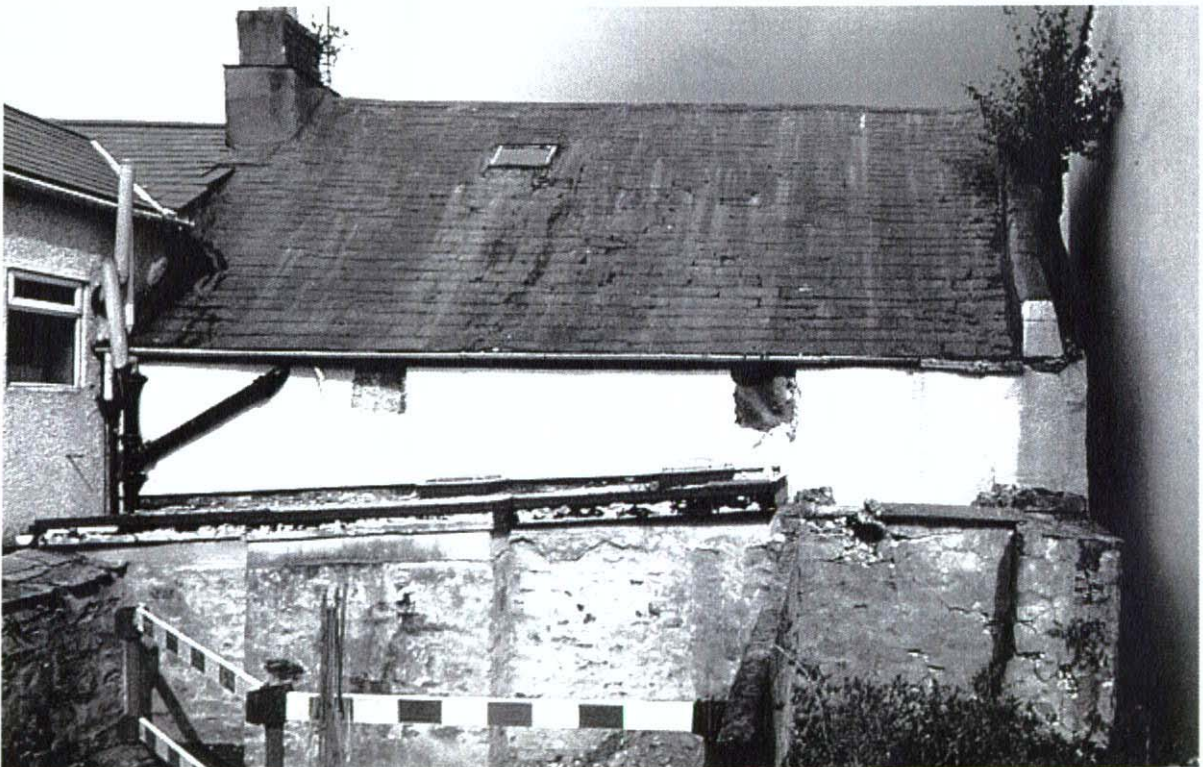
Plate 2 Rear elevation (pre works). Remains of former cottage in foreground; rendered rear wall; rag slate roof coated with bitumen; rendered stone and brick stack.

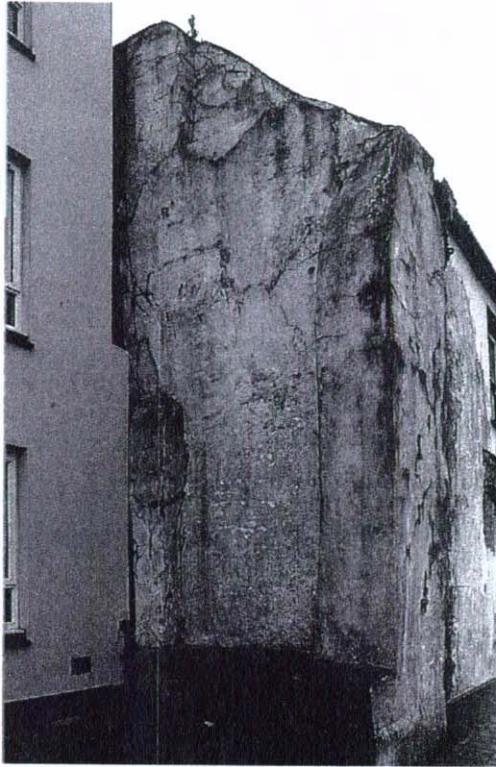
Plate 3 E gable end (pre works). Cracked and failing cement-based render obscuring structural problems of much of the wall. Gable later dismantled to eaves level.

1. *East Gable* Demolition of upper portion and rebuilding in lightweight concrete blockwork and lime mortar. Extensive stainless steel pin reinforcement with lime grouting of the wall core in the remaining stonework. Tile stitching crack repairs. Underpinning.

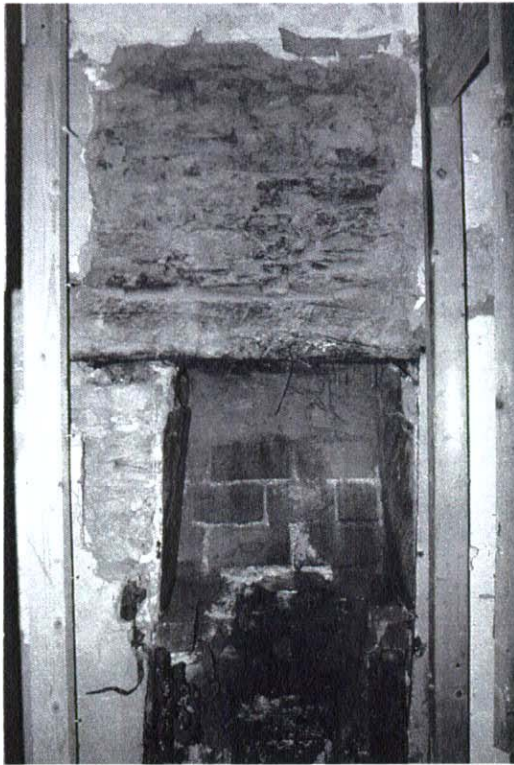
Plate 5 1<sup>st</sup>-floor RH room (fireplace with inverted lintel). Chamfered oak lintel with tongue stops, now upside-down, probably re-used when fireplace was remodelled.

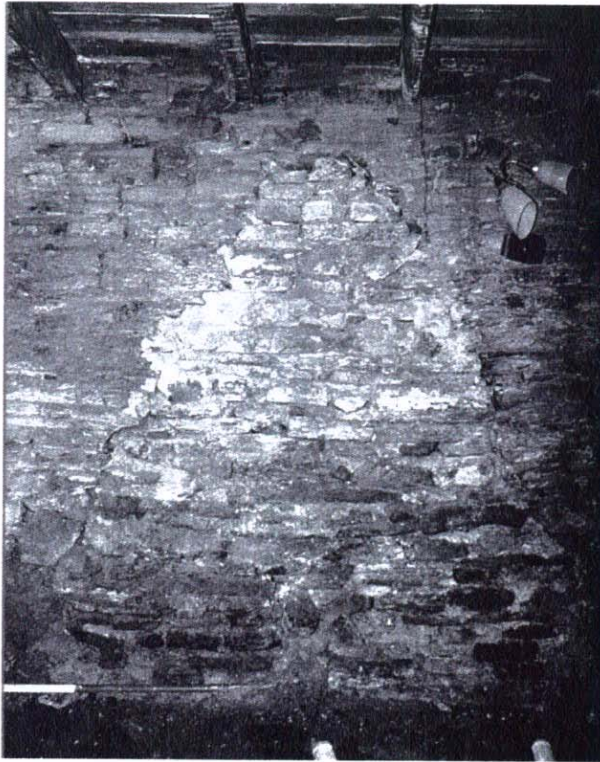
*East wall:* tall subsoil foundation resembling cob; good quality stonework with tooled surfaces (Plate 9); rebuilt section of wall, the rear of next door fireplace, right of centre; rebuilt masonry bedded in lime mortar adjoining right-hand corner; series of 3 putlog holes just below present ceiling level (Plate 7).

Plate 7 Ground floor LH room (E wall showing rebuilt fireplace back). Most of this wall is of an early date, built of fine rubble masonry and with putlog holes.

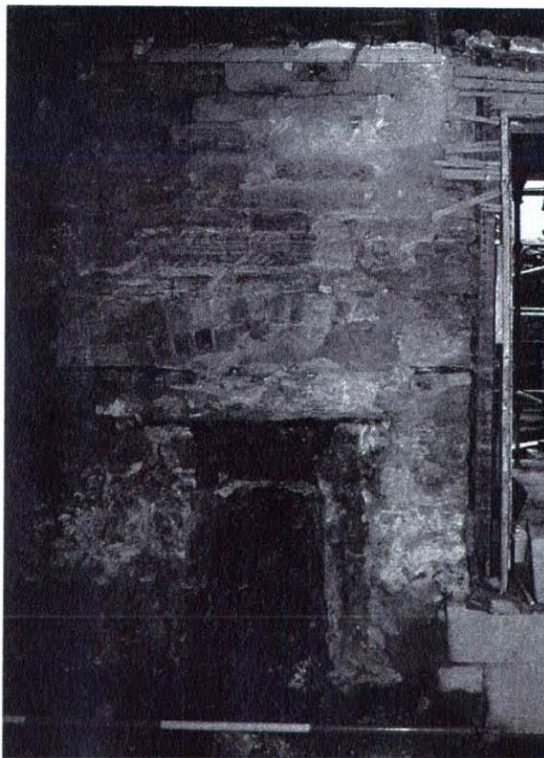
altered in the 19th century) in the left-hand room (Plate 8) is of this date. This suggestion is perhaps contradicted by the nature of the foundations at the rear of the building and for a distance supporting the return end walls. These foundations are original subsoil (resembling cob) that extend in places for a considerable distance above present floor level. The fact that they are shallower at the position of the rear stack seems to indicate a slightly later build, or that deeper foundations were considered necessary to support a heavy chimney breast.

Plate 8 Ground floor LH room (S wall showing fireplace). Original oak lintel removed and size of fireplace reduced in the 19<sup>th</sup> century. Foundation shallower than that of E wall.

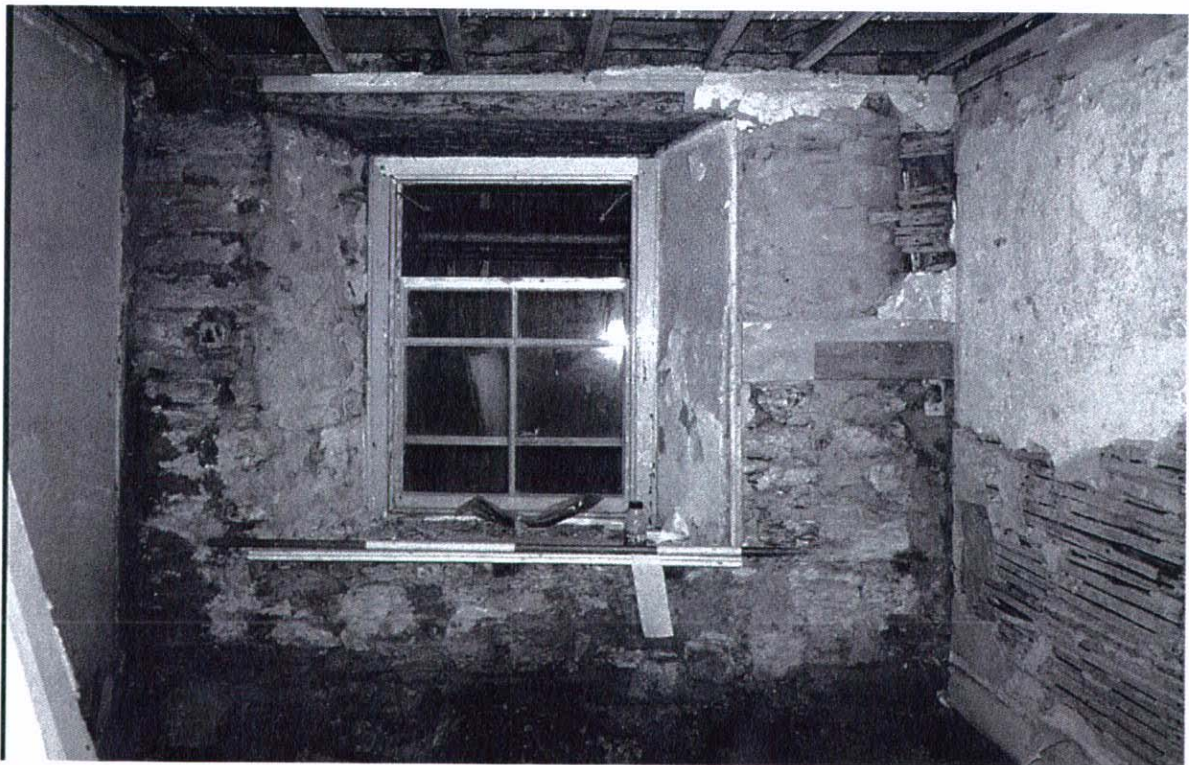
Plate 12 Ground floor RH room (N wall: altered window openings; joist sockets for earlier 1<sup>st</sup> floor, and support for former wooden ground floor).

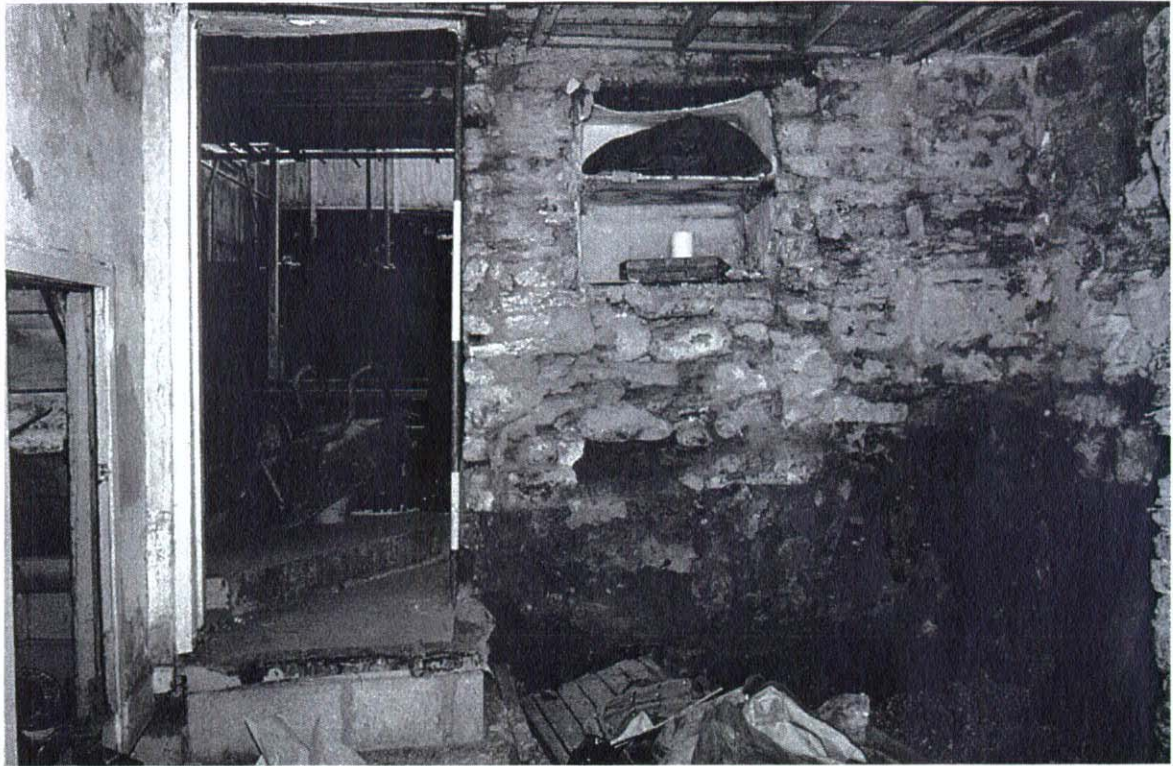
Plate 13 Ground floor RH room (S wall with foundations and keeping place). Very high foundations indicate build method on a sloping site. Most of wall probably 18<sup>th</sup> century.

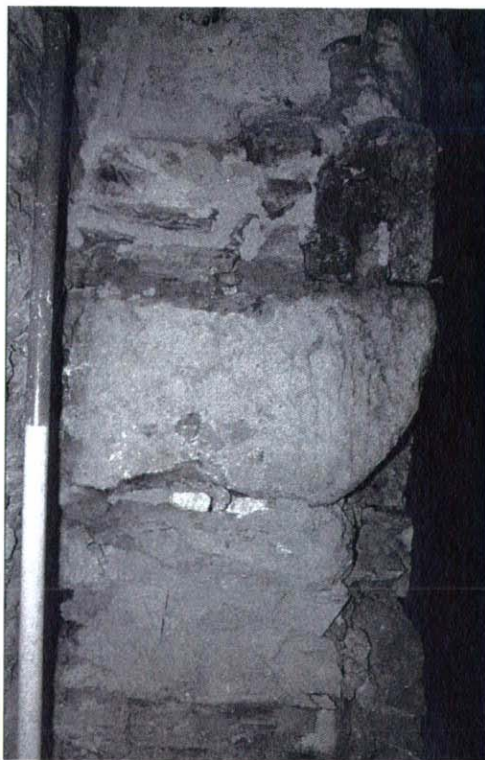
Plate 16 Principal fireplace LH return (granite corbel and oak lintel end with old mortise indicating re-use).

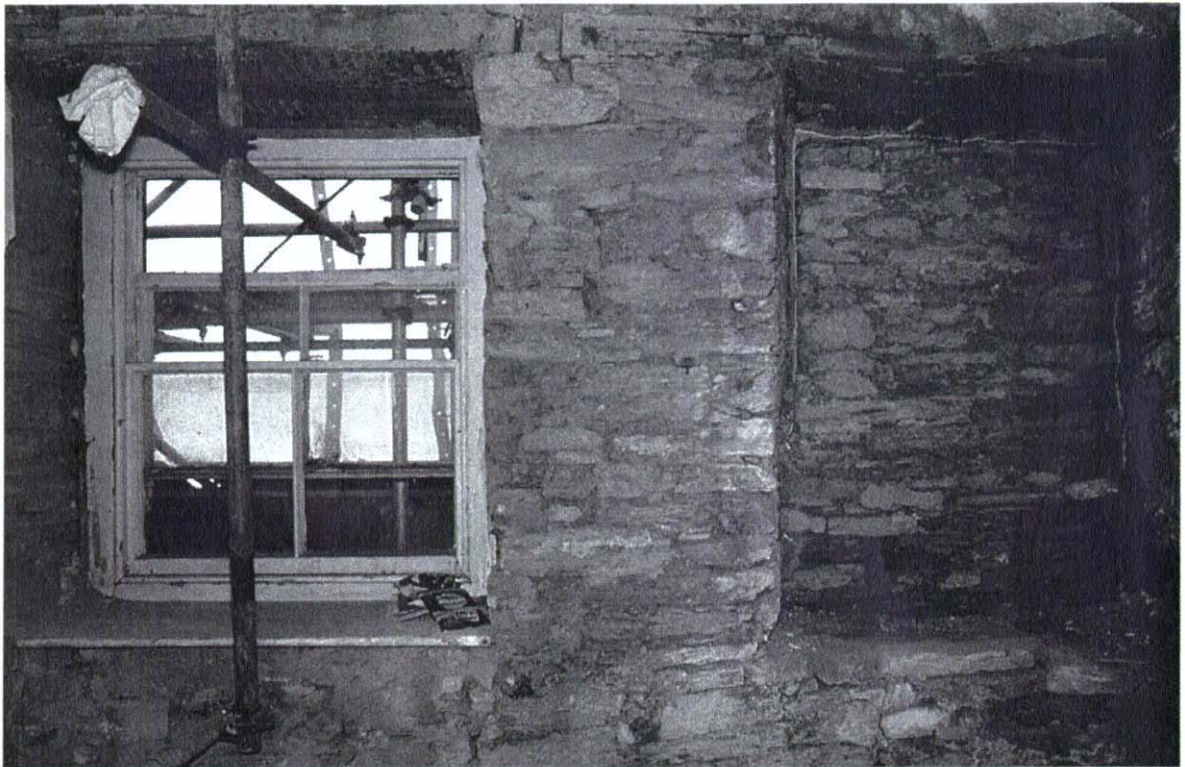
Plate 17 1<sup>st</sup> floor LH room (existing window and blocked window). Re-used oak lintels.

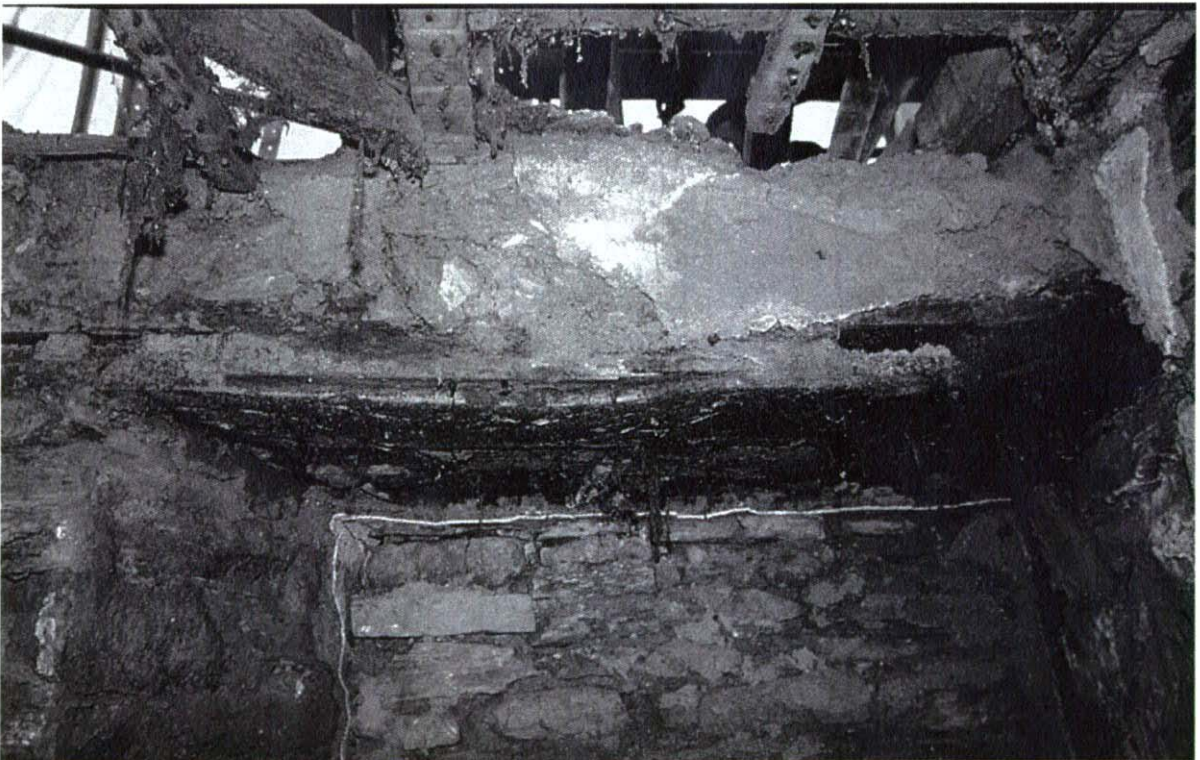
Plate 18 1<sup>st</sup> floor LH room (NE corner showing blocked window and re-used roof timber). Re-use of collar from 16<sup>th</sup> century arch-braced roof structure.

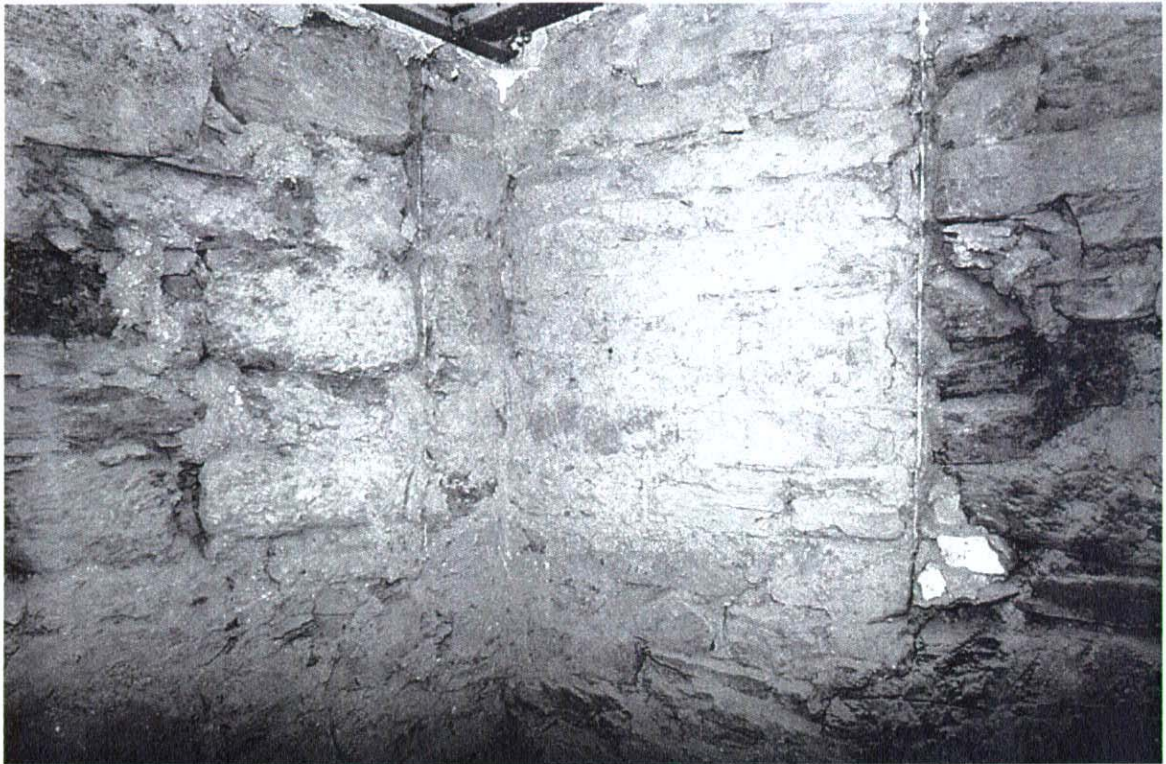
Plate 21 1<sup>st</sup> floor RH room (blocked opening in SW corner). Blocked window opening.

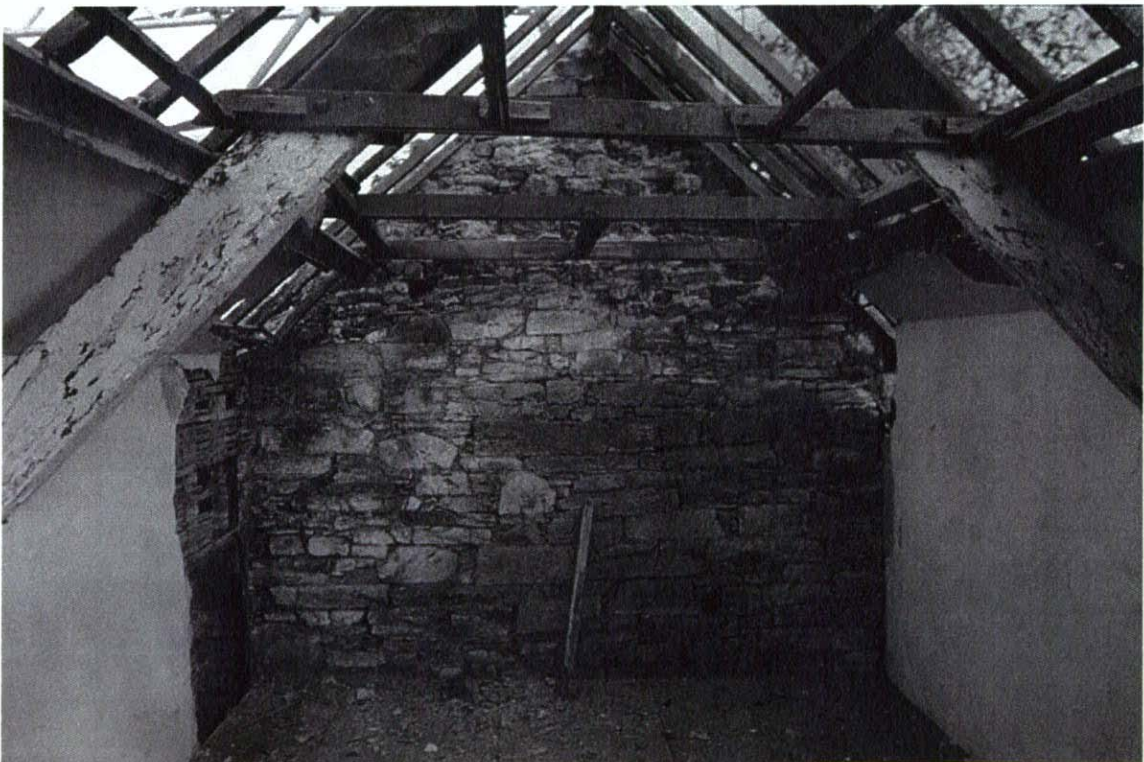
Plate 22 E gable (interior prior to demolition). Note good quality rubble masonry (but leaning outwards due to failed structure underneath)

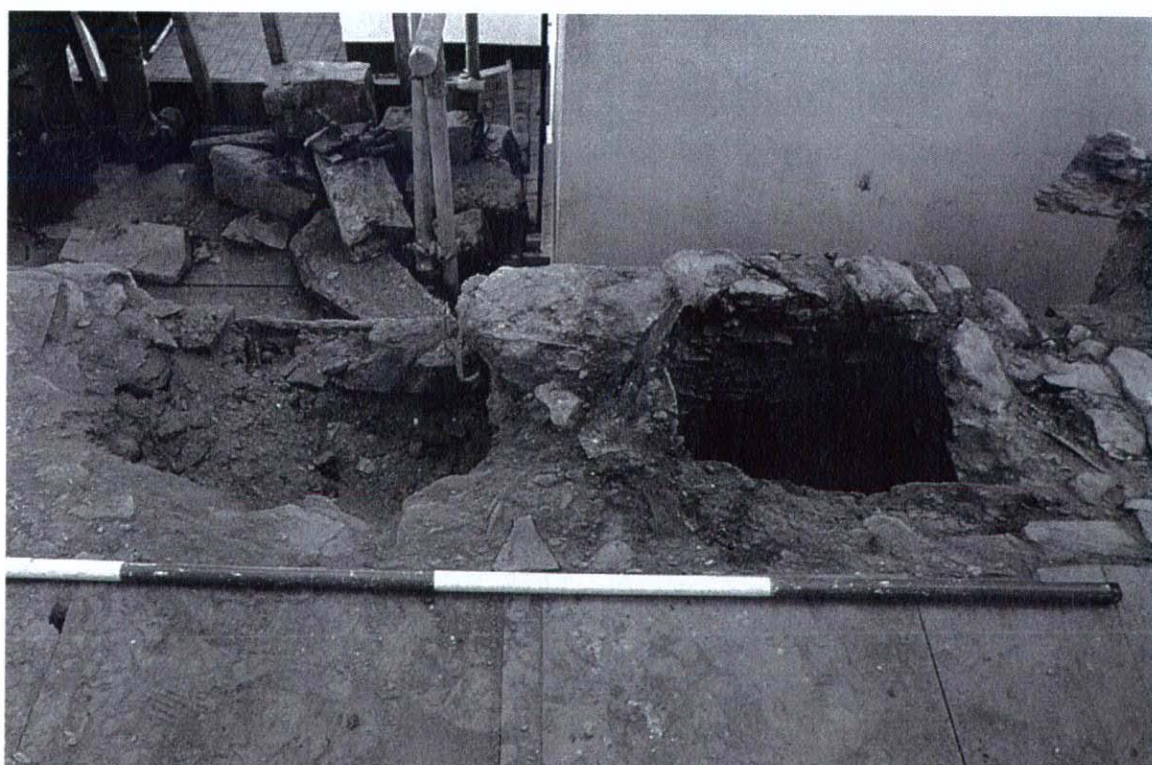
Plate 24 E gable end wall (flues to attic floor level). Both flues for adjacent former house prior to demolition and rebuilding of outer skin of flues.

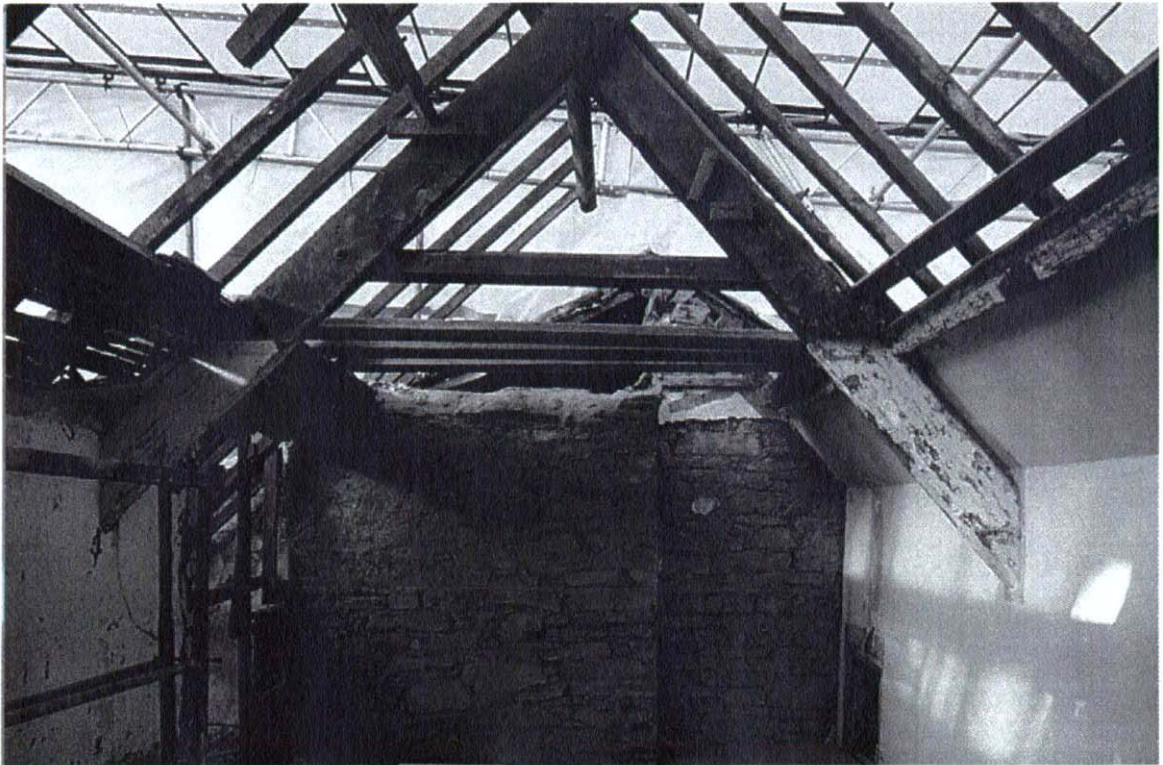
Plate 25 W gable. Unstable stone stack removed.

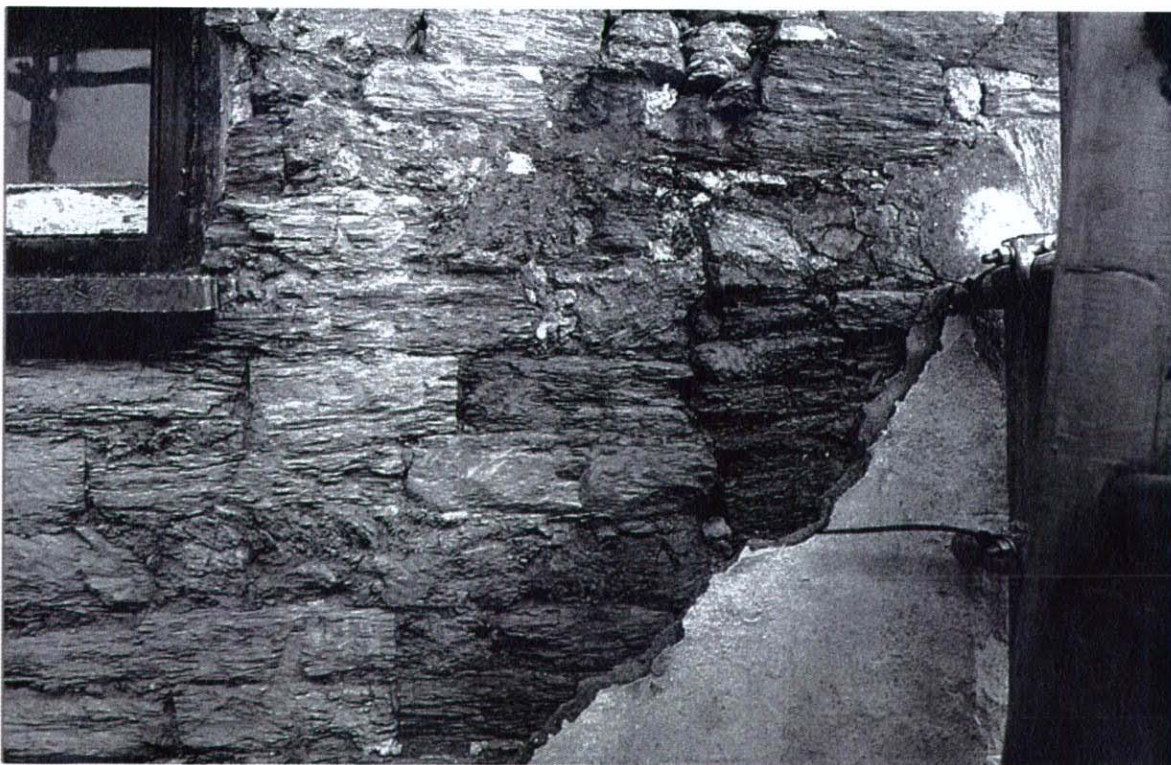
*North wall:* large stone foundation blocks under jambs of present central inserted doorway remaining from probable original c1600 doorway; oak lintels (probably re-used); evidence for most openings reduced in width; evidence for later lowered cills; blocked window over blocked doorway at left; short section of wall of former No 18 (out of alignment) at far left; ragged joint of rebuilding at far right; some probable blocked putlog holes; remains of early 20<sup>th</sup> century cement mortar pointing; remains of cement mortar render with incised lines to resemble blocked-out stucco (Plates 27 and 28)

Plate 28 Front wall RH side (window alteration and evidence of rebuilding + remains of incised render).

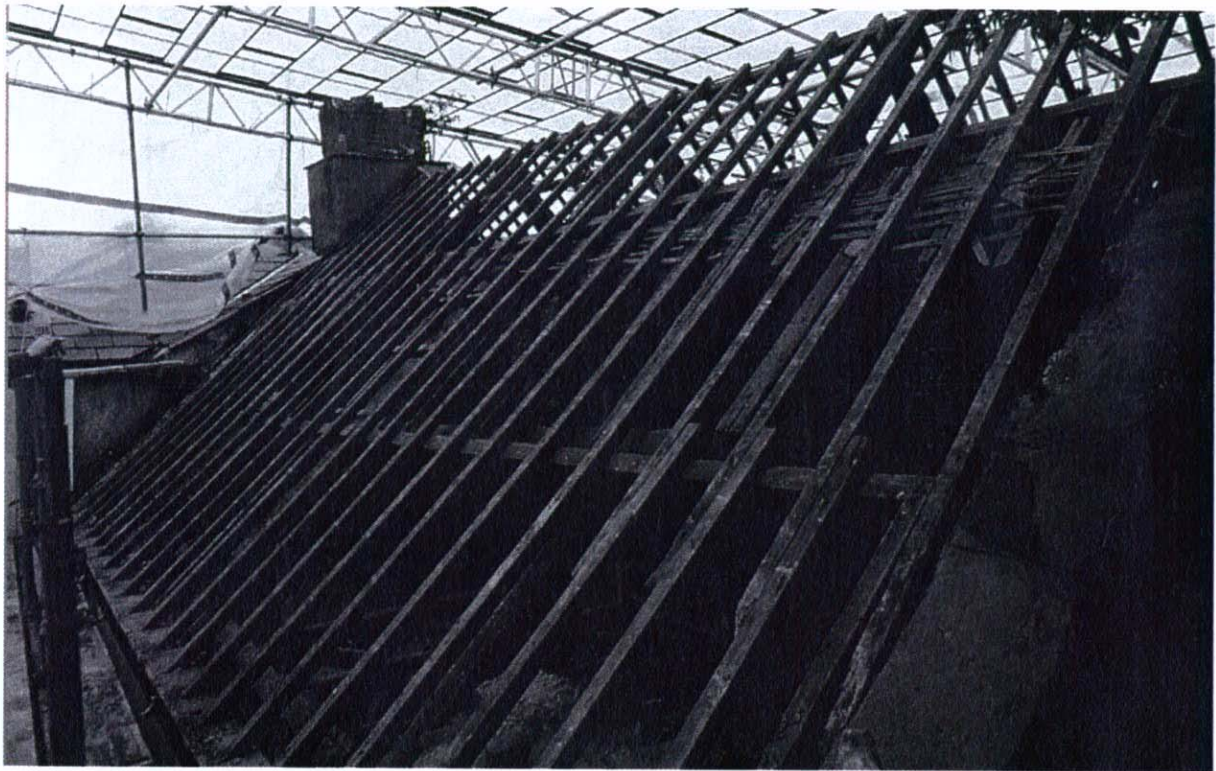
Plate 35 Roofline towards west (chimney stack prior to demolition + scaffolding protection system)
