**20 Lower Bore Street, Bodmin, Cornwall**  
**Archaeological Survey and Historical Analysis**

A Report for  
Cornwall Buildings Preservation Trust  
and North Cornwall District Council

March 2001

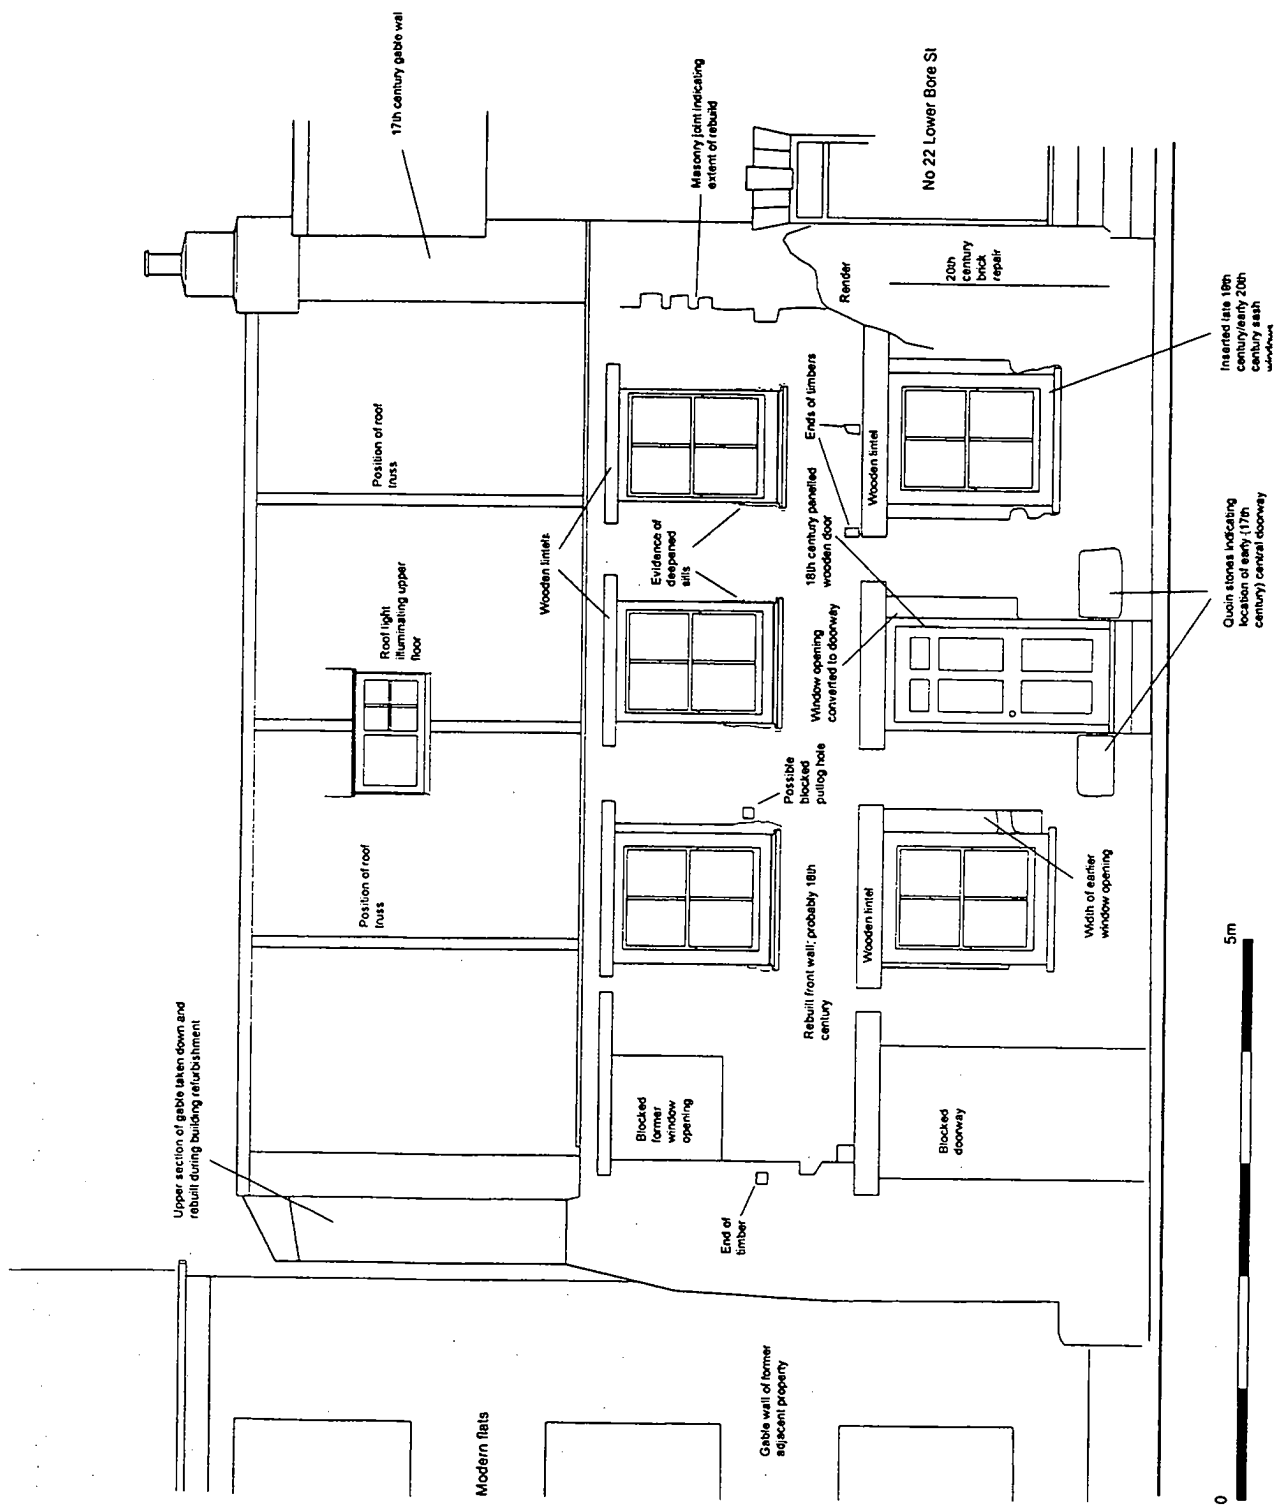
Fig 6 Front elevation of No 20, showing rebuild line of wall and earlier layout of openings (survey by Barlow Schofield Architects and additional information by CAU)

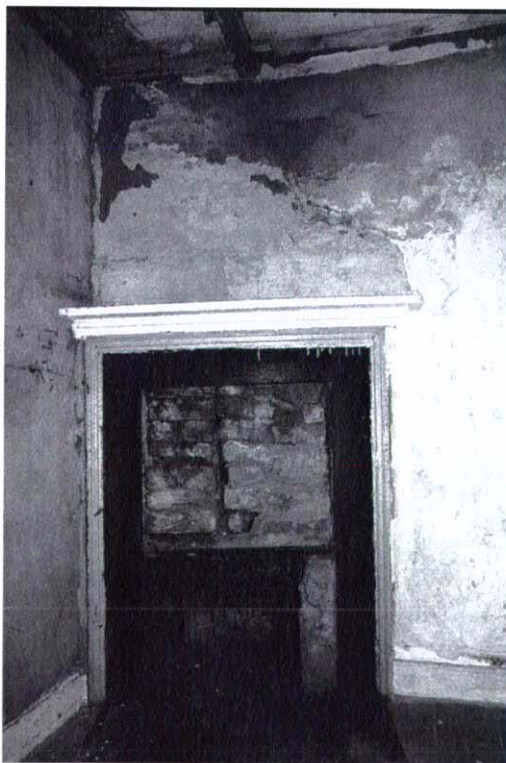
Plate 4 1<sup>st</sup>-floor LH room. (c1800 chimney-piece). Simple moulding and moulded shelf suggests a late 18<sup>th</sup> or early 19<sup>th</sup> century date; simple hobs and grate.

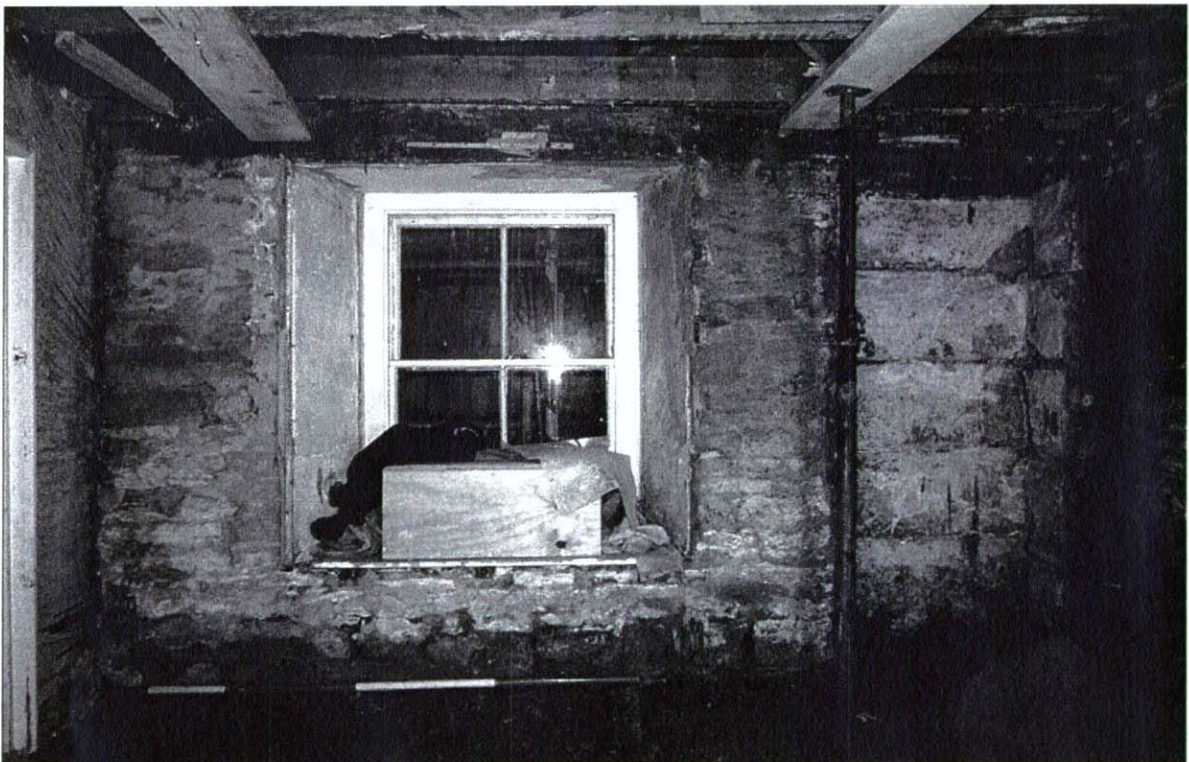
*North wall:* evidence of window narrowing to the left-hand jamb; blocked doorway on the right and there is evidence for two joist sockets from the previous floor structure (Plate 6).

Plate 6 Ground floor LH room (N wall, altered window opening and blocked doorway).

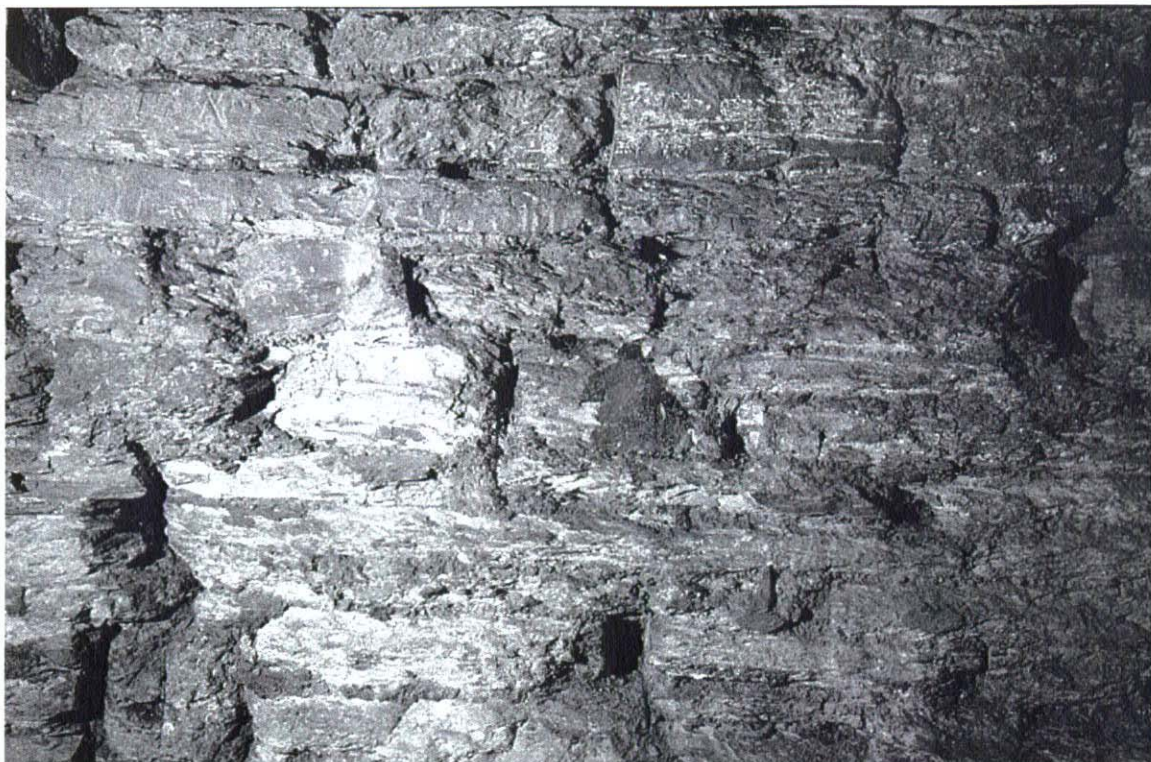
*East wall:* tall subsoil foundation resembling cob; good quality stonework with tooled surfaces (Plate 9); rebuilt section of wall, the rear of next door fireplace, right of centre; rebuilt masonry bedded in lime mortar adjoining right-hand corner; series of 3 putlog holes just below present ceiling level (Plate 7).

Plate 9 Ground floor E wall (tooling on stones). Generally well constructed and tooled rubble masonry reinforcing opinion about an early date.

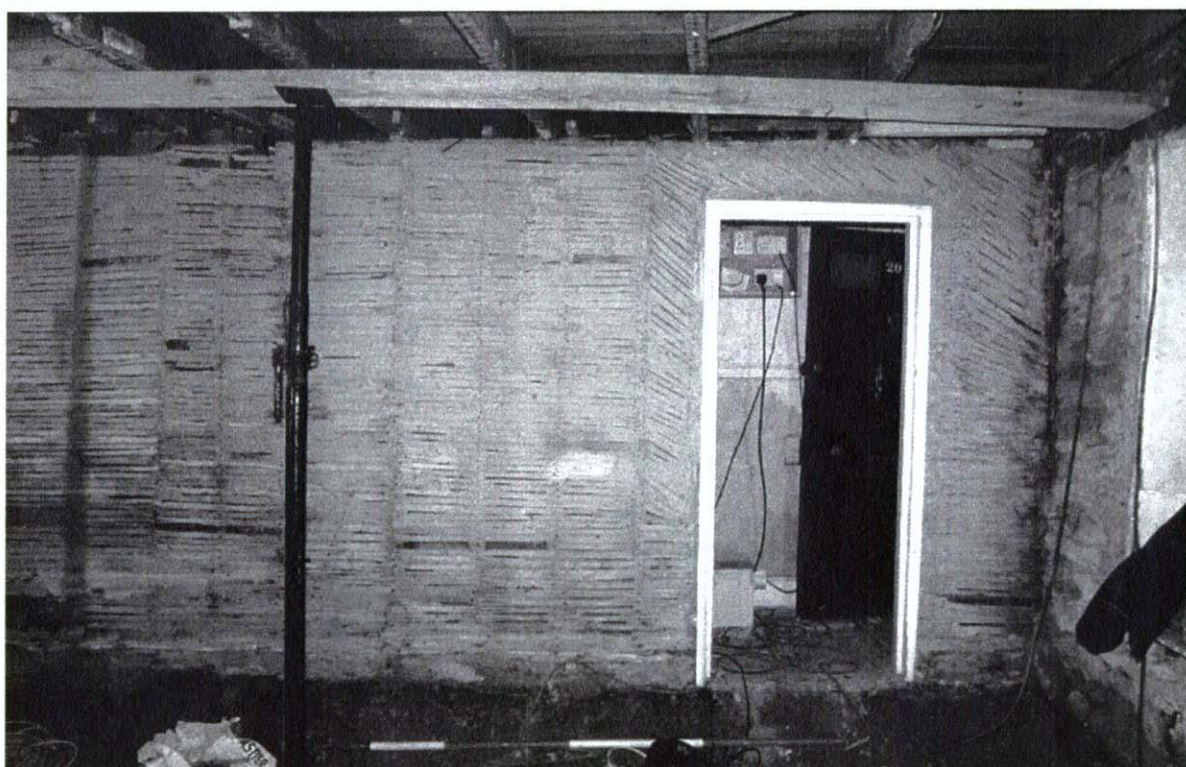
*West partition:* exposed laths on studwork, the laths set diagonally in places (Plate 10).

Plate 10 Ground floor LH room (lath construction of internal partition c1800). Good example for use of regular split-lath lengths generally but also using some diagonally set laths.

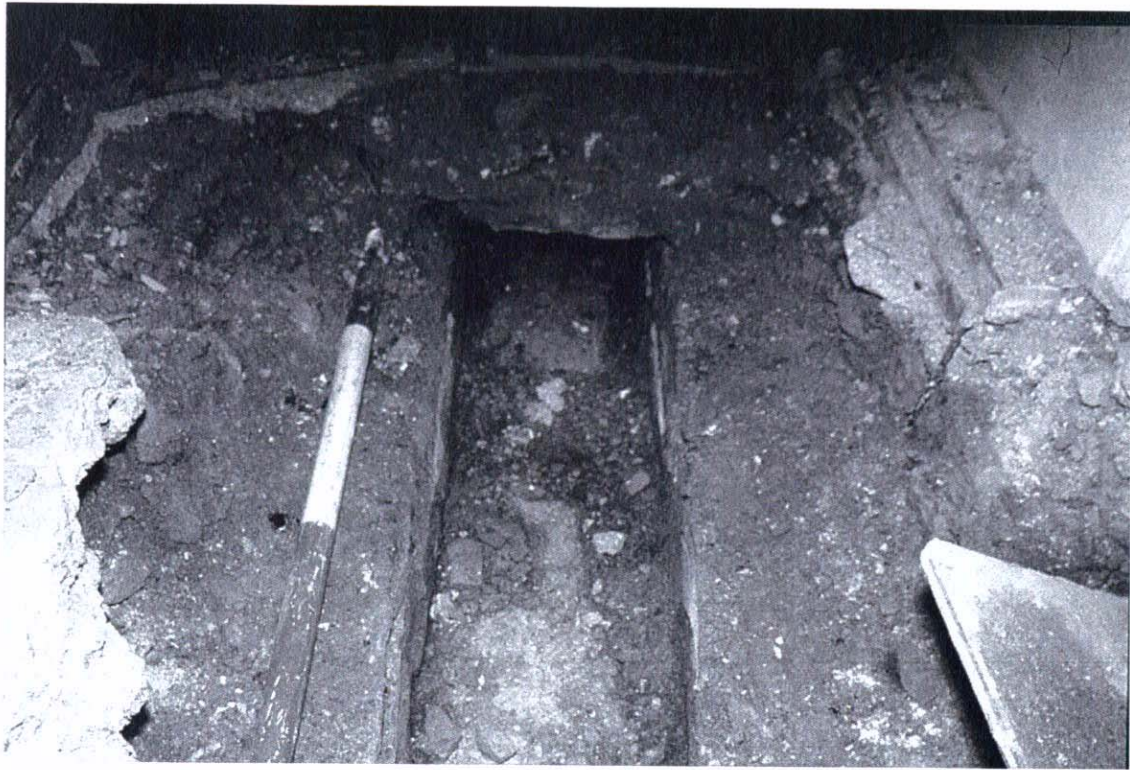
*Features:* slate floor drain revealed under polychrome and patterned flooring (Plate 11); winders from right-hand room to straight-flight staircase, the newel post with late 18th century character.

Plate 11 Entrance hall (slate land drain revealed under c1900 tiled floor). Unusual feature but similar drain found recently at Manaccan former vicarage.

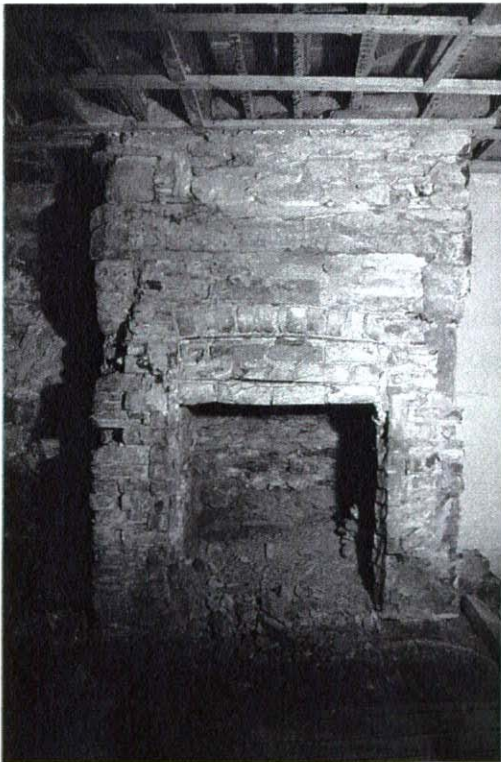
*West wall:* original c1600 fireplace (with re-used chamfered oak lintel on unequal granite corbels and granite monolith jambs); stone rubble hearth; shallow recess to wall left of fireplace; evidence of former cupboard left of fireplace; re-used, mortised oak fragment as trimmer/bearer of first floor hearth stone: joists ends to wall (Plates 14, 15 and 16). Intact area of plaster right of fireplace possibly concealing blocked inserted communicating doorway with No 22.

Plate 14 Ground floor RH room (principal fireplace partly opened up).

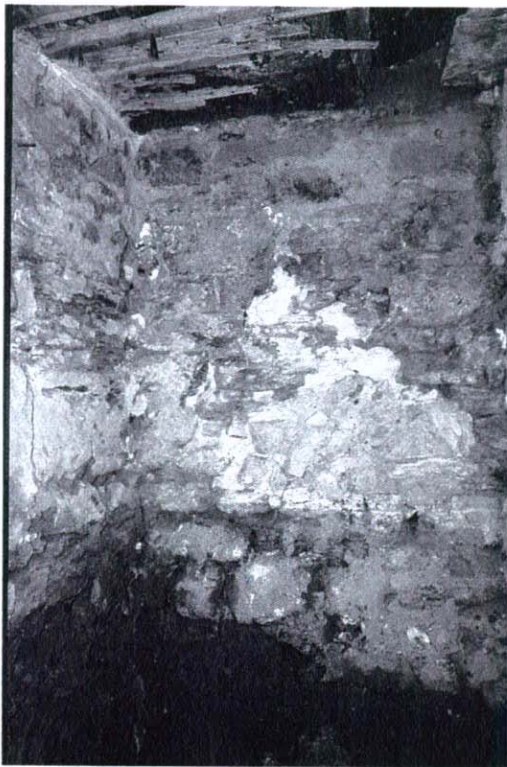
Plate 15 Ground floor RH room (recess at SW corner). Probable former window opening with lime plaster visible in the splayed jambs.

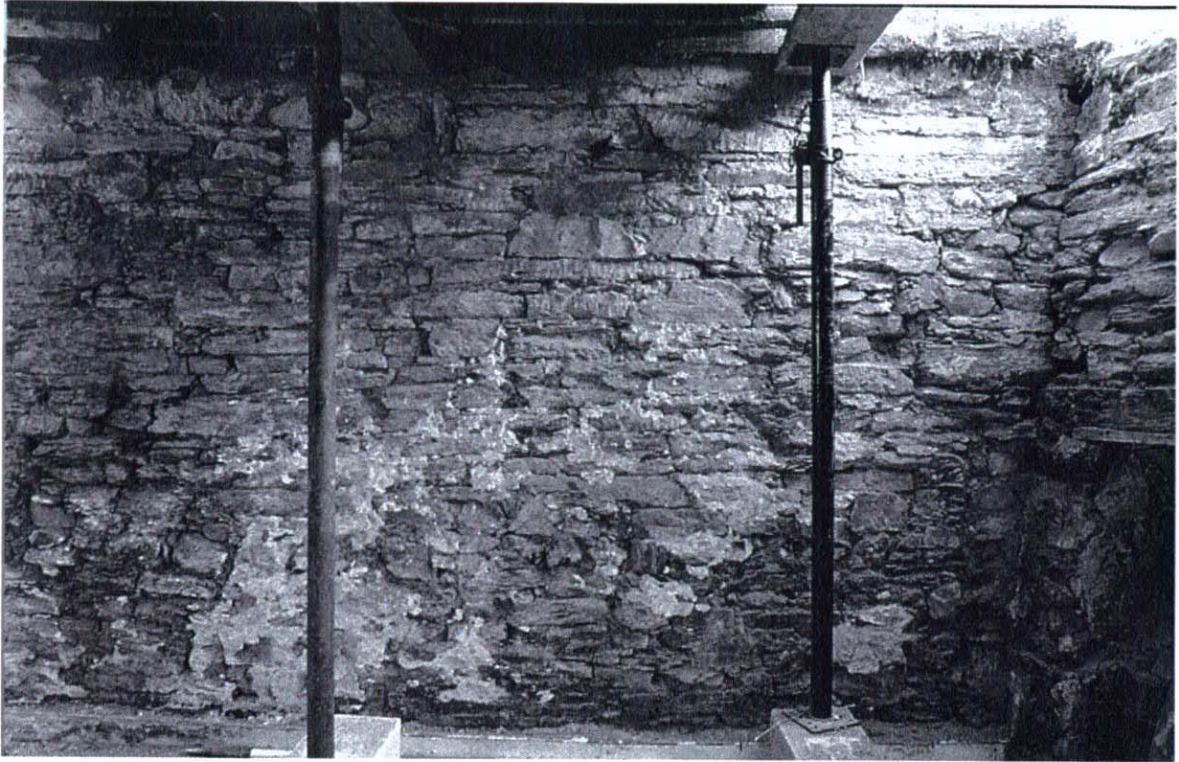
*East wall:* good quality stonework with tooled surfaces; two possible blocked putlog holes; evidence for rebuilding by SE corner relating to corner fireplace (Plate 19).

Plate 19 1<sup>st</sup> floor LH room (E wall including rebuild on right to include chimney)

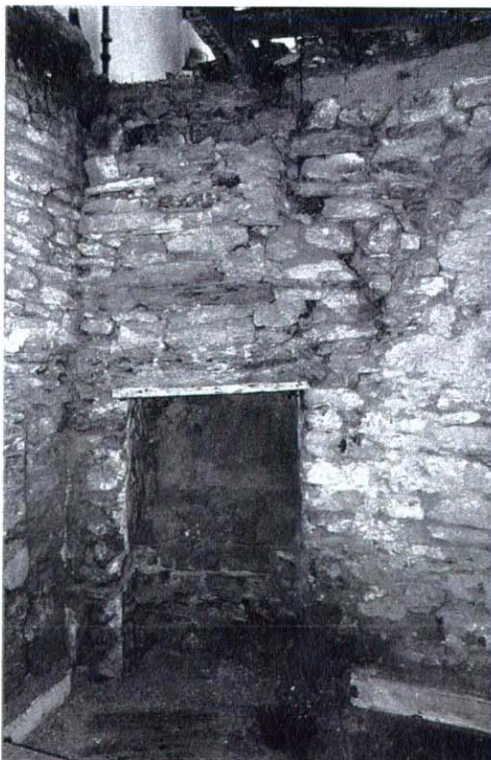
*South wall:* corner fireplace spanned by oak lintel, with evidence of rebuilding/insertion; two putlog holes near right-hand corner; part of oak beam as wall plate spanning stair/circulation area; varied width ceiling/loft joists end on to wall (Plate 20).

Plate 20 1<sup>st</sup> floor LH room (rear wall, fireplace). Note rebuilt walling surrounding fireplace.

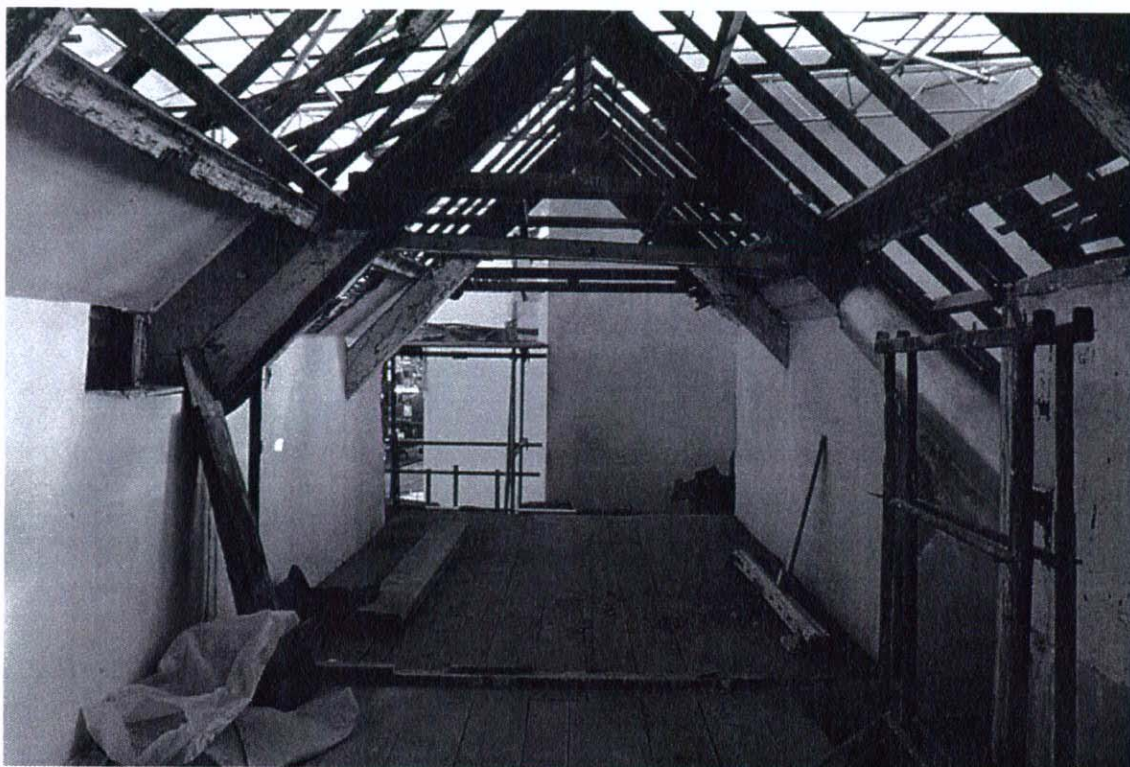
Plate 23 E gable (post demolition). Note roof structure and floor construction.

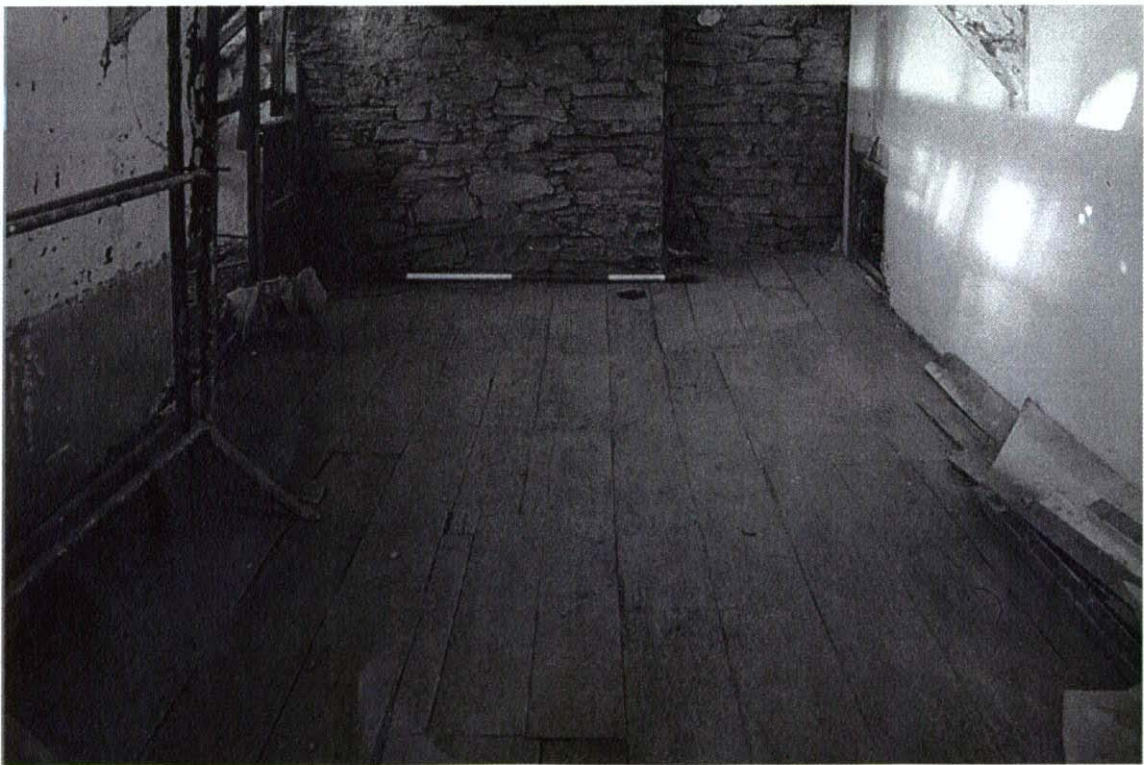
*West gable wall:* chimney breast with rebuilt section; stack removed by time of survey; short length of probable original 16<sup>th</sup> century purlin set into wall top (Plates 25 and 26).

Plate 26 Attic floor (towards west showing floorboard arrangement)

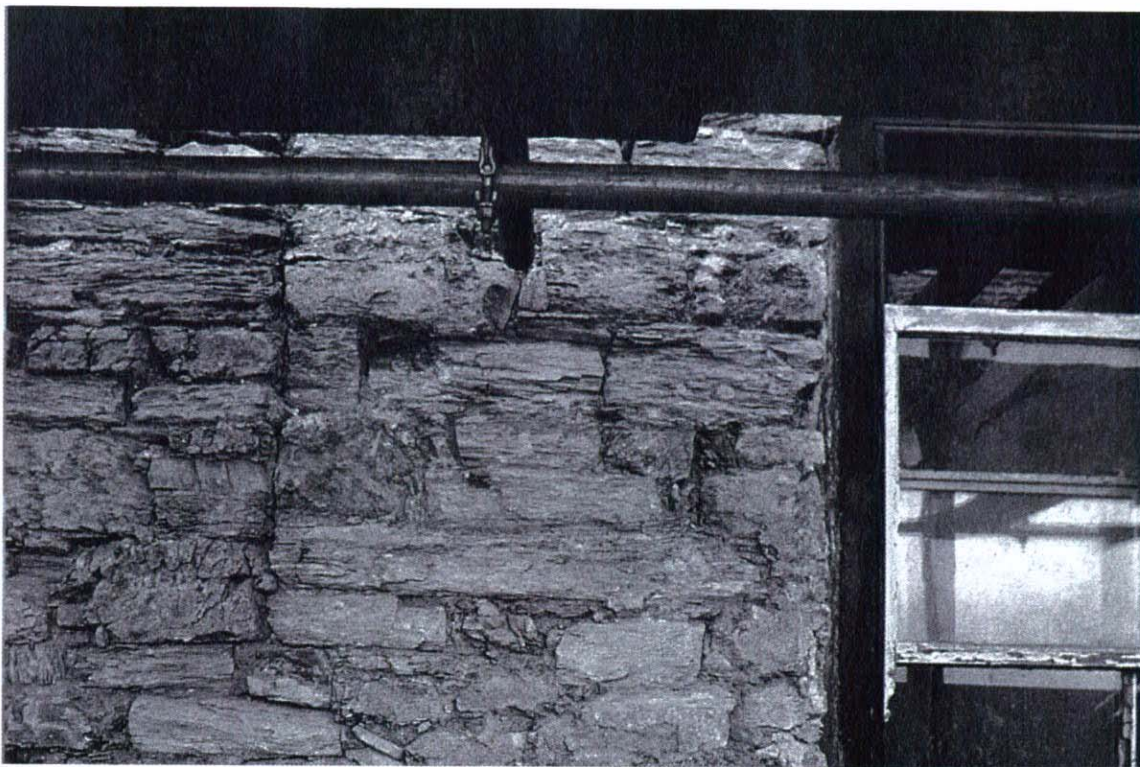
*North wall:* large stone foundation blocks under jambs of present central inserted doorway remaining from probable original c1600 doorway; oak lintels (probably re-used); evidence for most openings reduced in width; evidence for later lowered cills; blocked window over blocked doorway at left; short section of wall of former No 18 (out of alignment) at far left; ragged joint of rebuilding at far right; some probable blocked putlog holes; remains of early 20<sup>th</sup> century cement mortar pointing; remains of cement mortar render with incised lines to resemble blocked-out stucco (Plates 27 and 28)

Plate 27 Front wall (1<sup>st</sup> floor LH side showing blocked window).

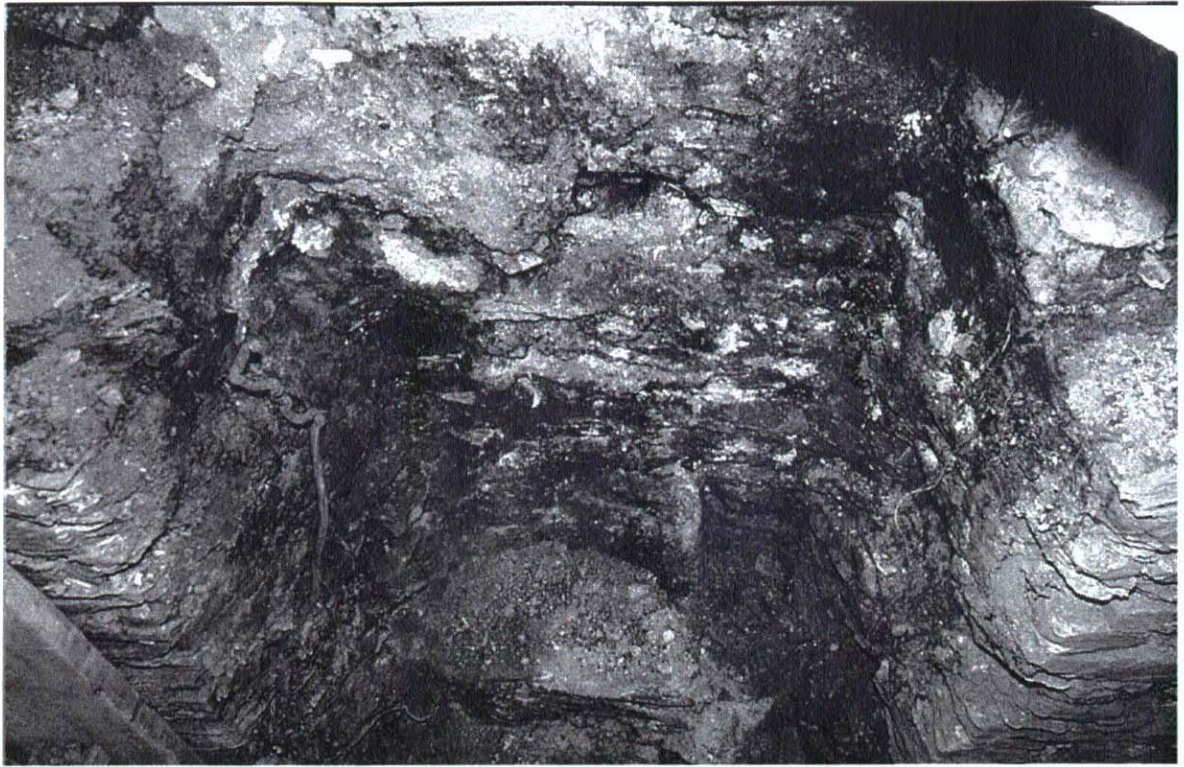
*East wall:* blocked fireplaces re-opened (Plate 29)

Plate 29 E wall (1<sup>st</sup>-floor fireplace of former No 18 with splayed jambs and shaped granite fire back).

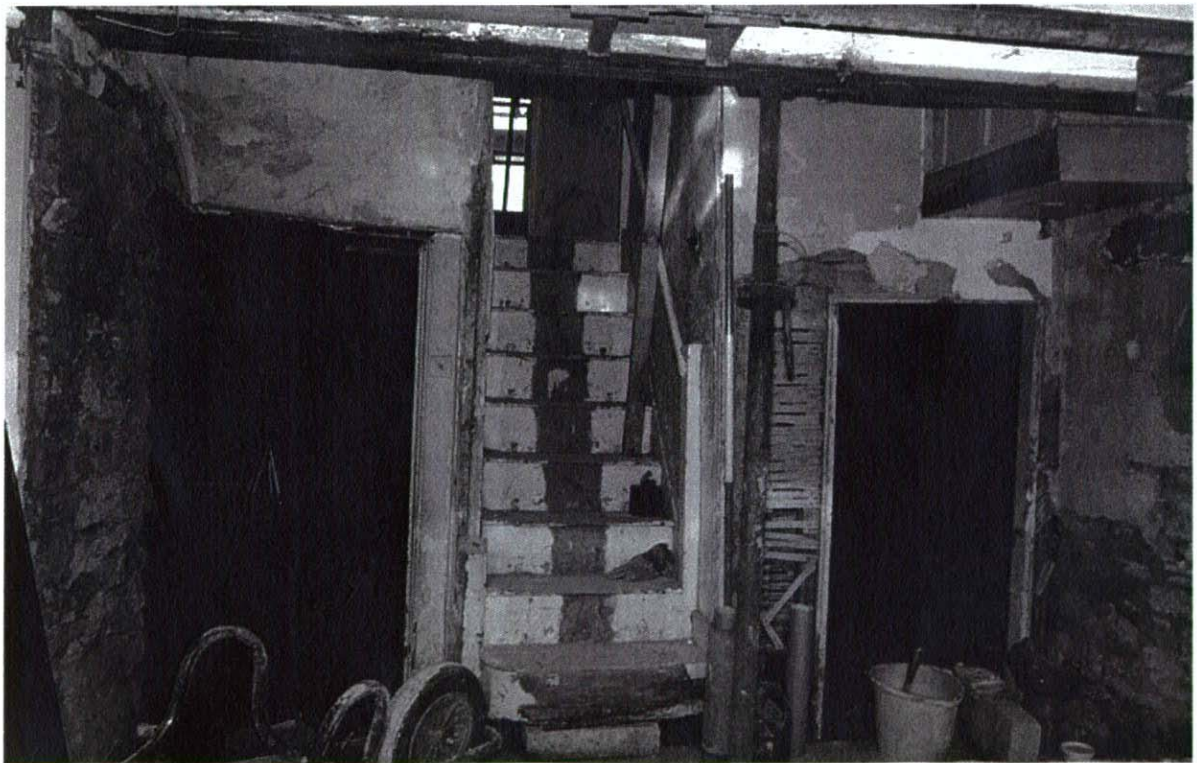
Plate 30 Stairs to ground-floor level. Note thick masonry walls at left and right.

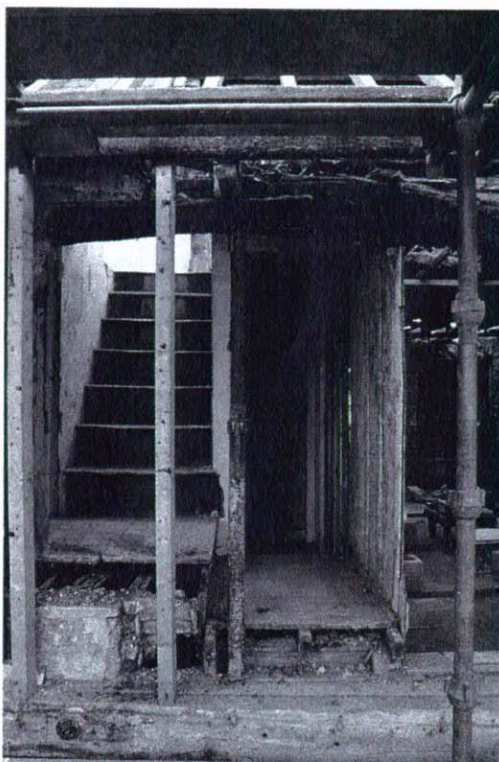
Plate 31     Stairs to 1<sup>st</sup>-floor level. Note muntin and plank partition right of stair passage.

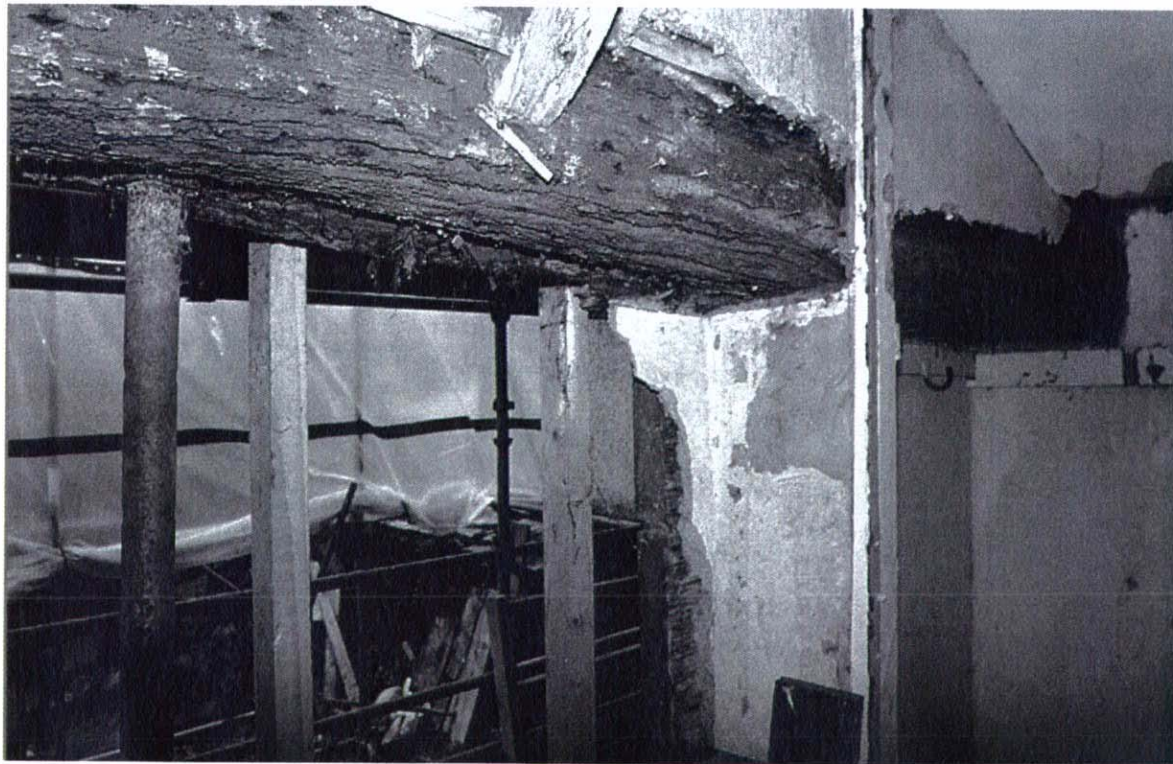
Plate 32     Rear wall (beam linking walls and supporting roof in staircase area).

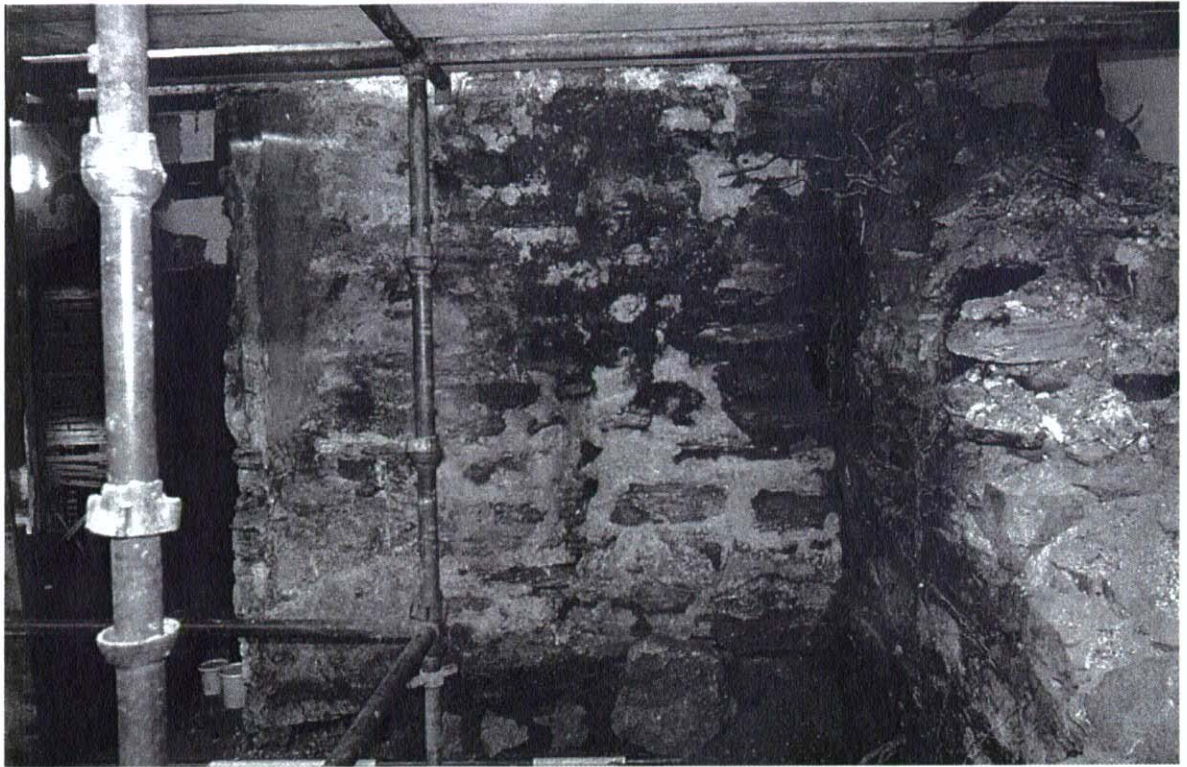
Plate 33 Ground floor rear wall adjacent to SE corner (extent of wash house of No 20 feeding to flue of back kitchen of former No 18).

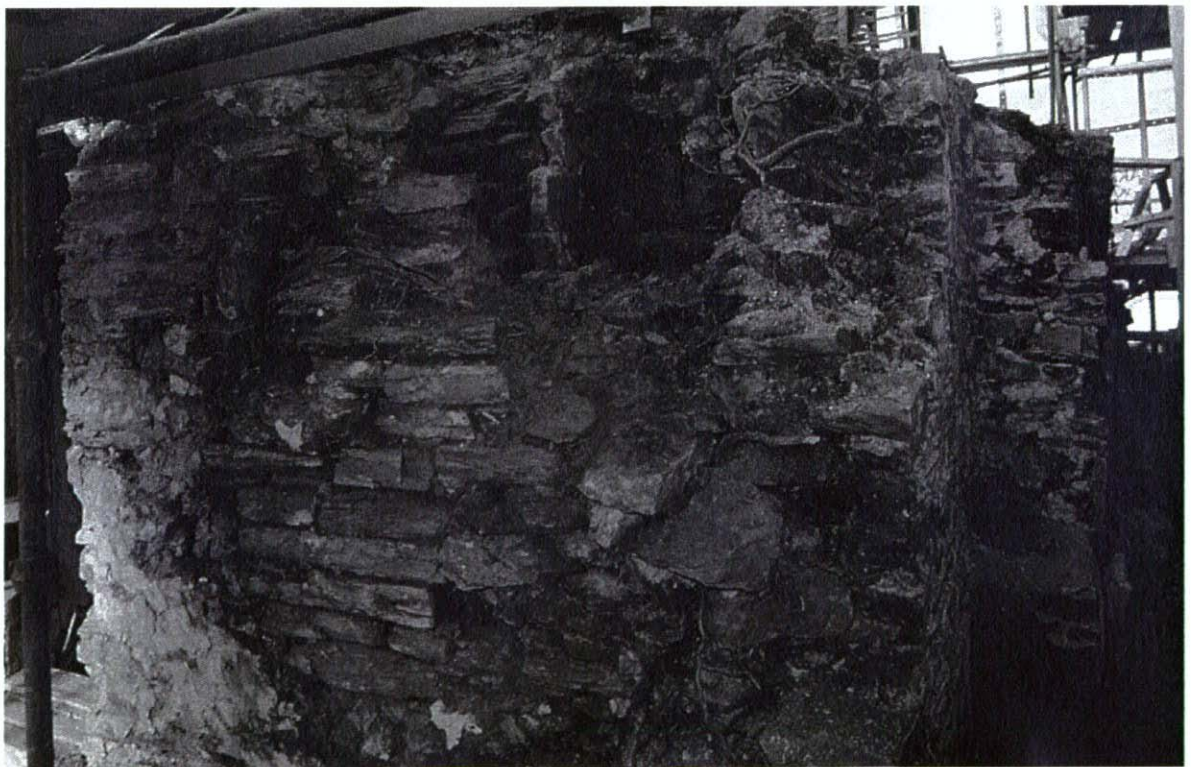
Plate 34 Exterior SE corner (remodelling phases and flues).

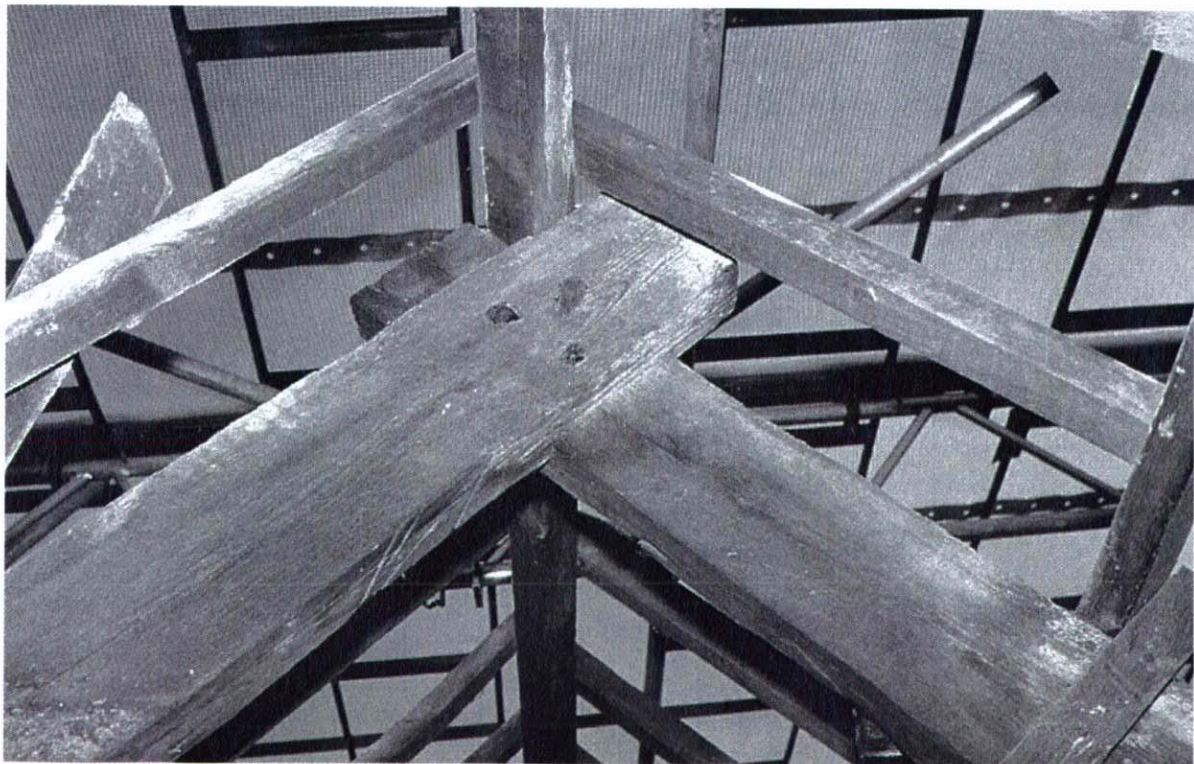
Plate 36 Roof structure (apex detail). Use of both wooden peg and wrought-iron nails.

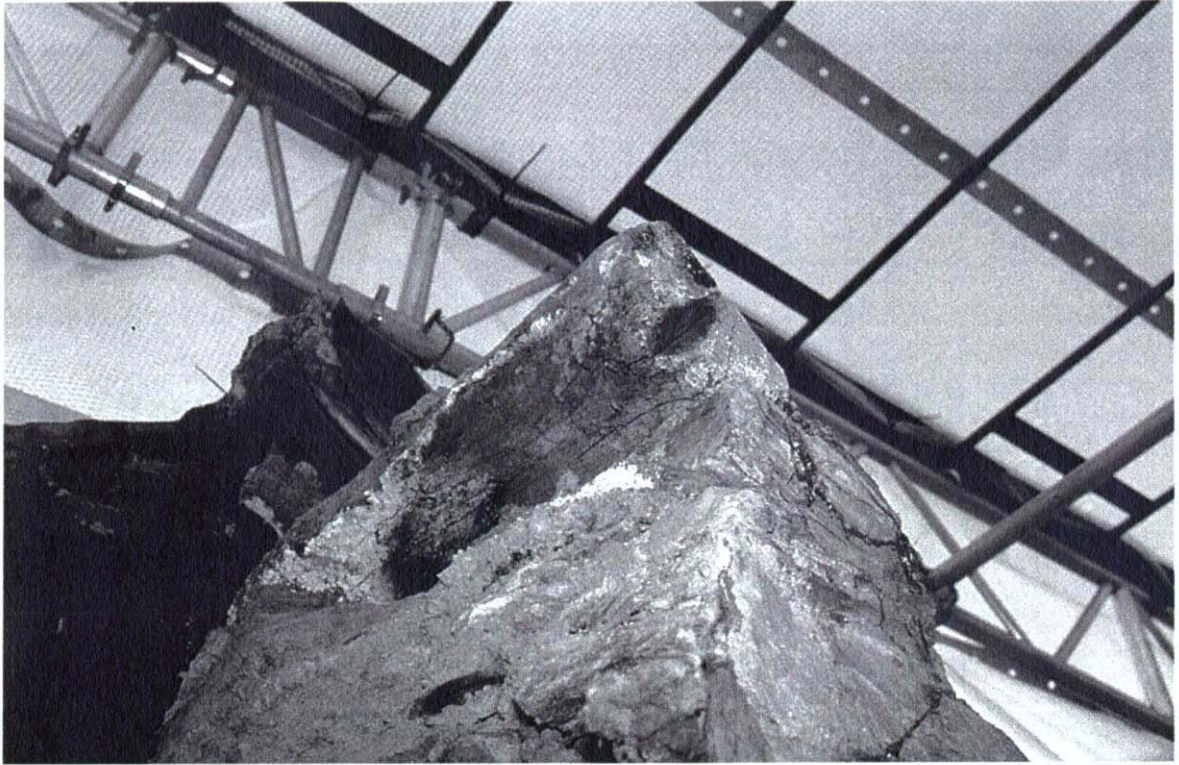
Plate 37     Detail of W gable (purlin remnant possibly from 16<sup>th</sup> century roof structure).
